City of Detroit  
Department of Recreation Performance Audit  
Exhibit 1 – Grayhaven Marina

**Overall Evaluation – Fair Condition**

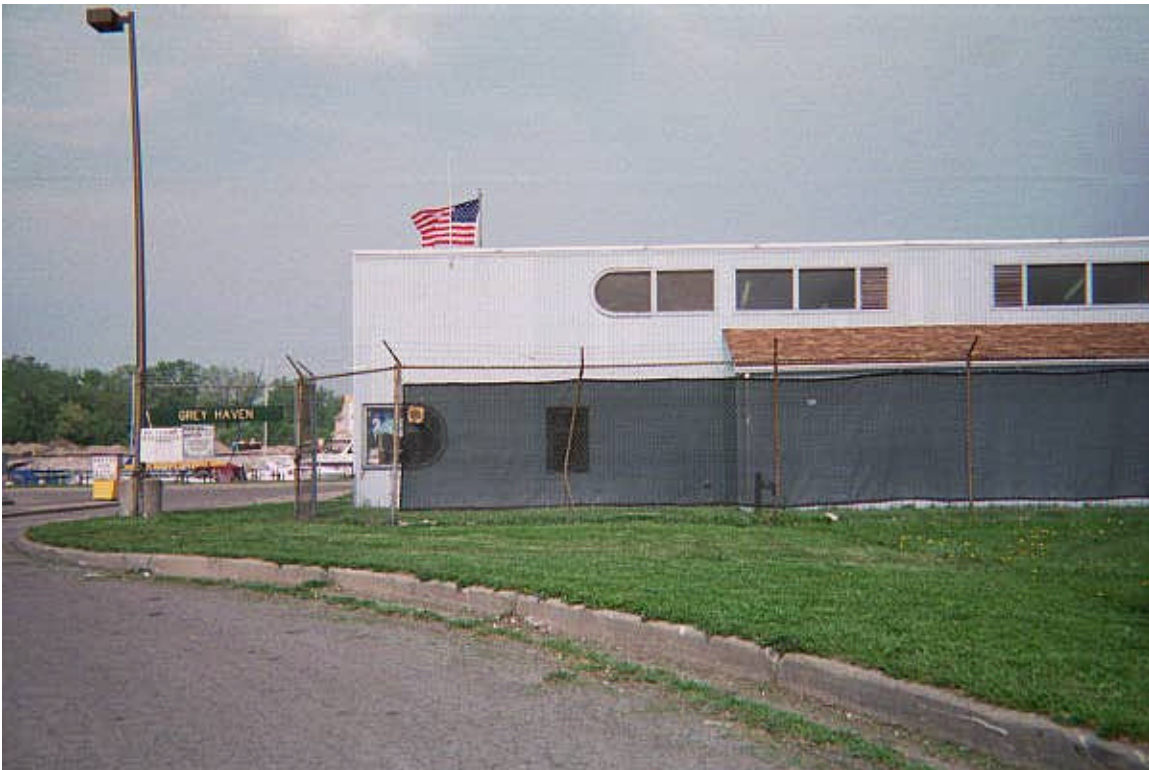
Entrance to Grayhaven Marina, which was aesthetically unappealing.

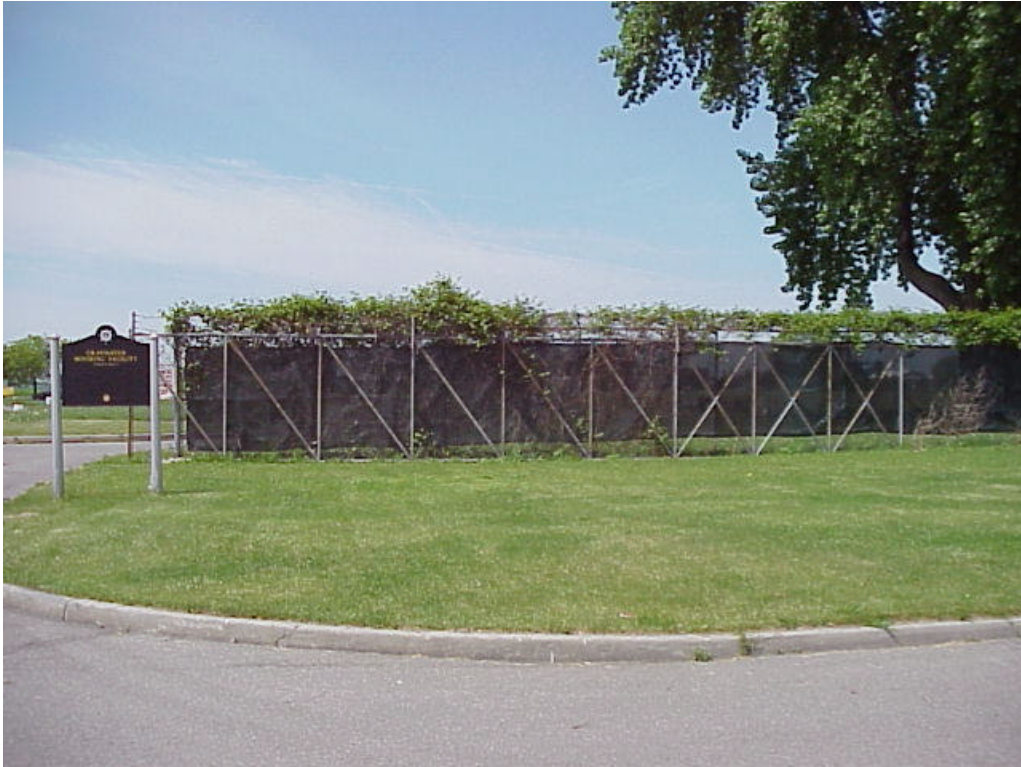
Inside view of Grayhaven's fence which was aesthetically unappealing.

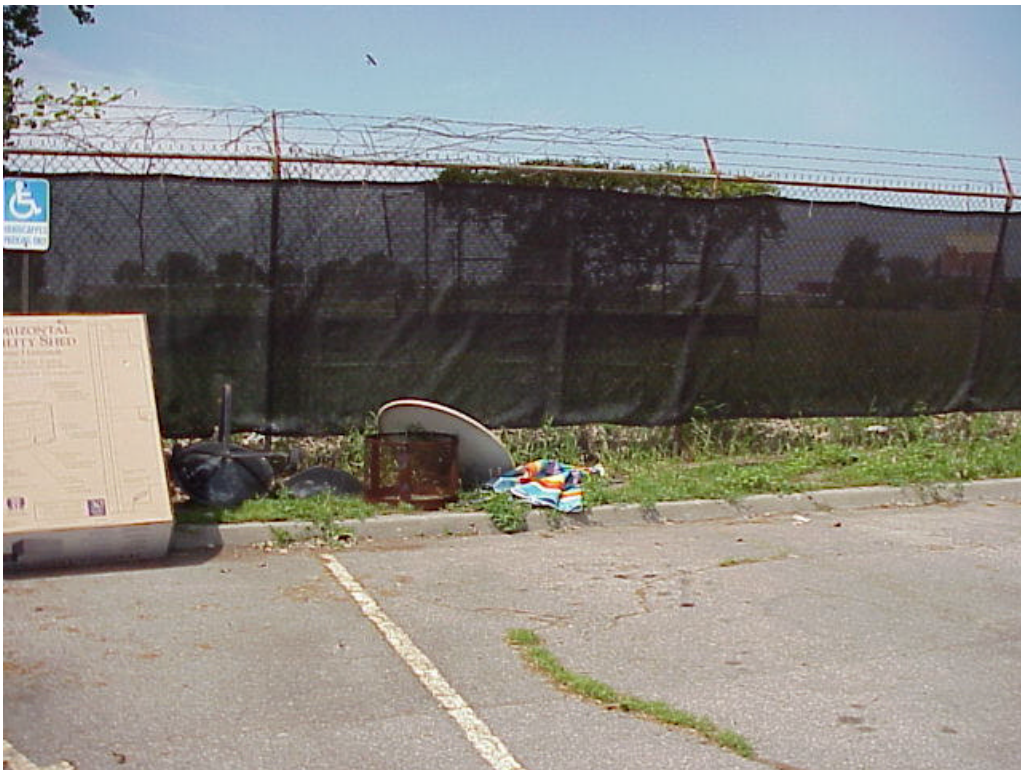
Trash and debris beside the Grayhaven parking lot.

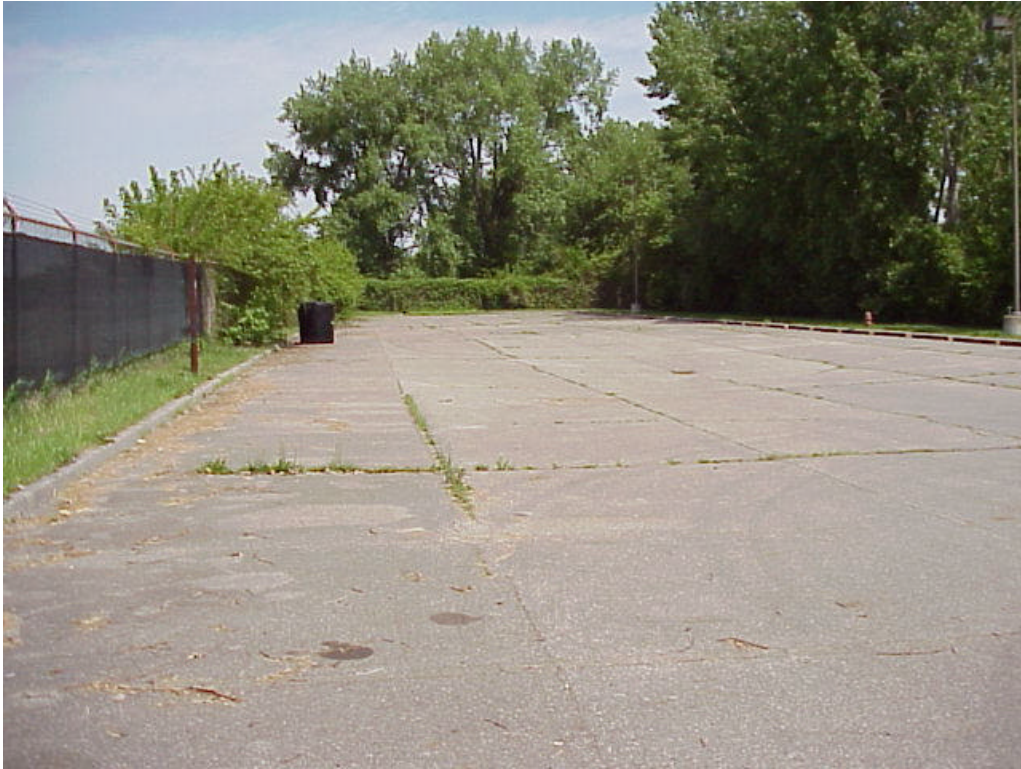
Cracks and grass growing through Grayhaven parking lot.

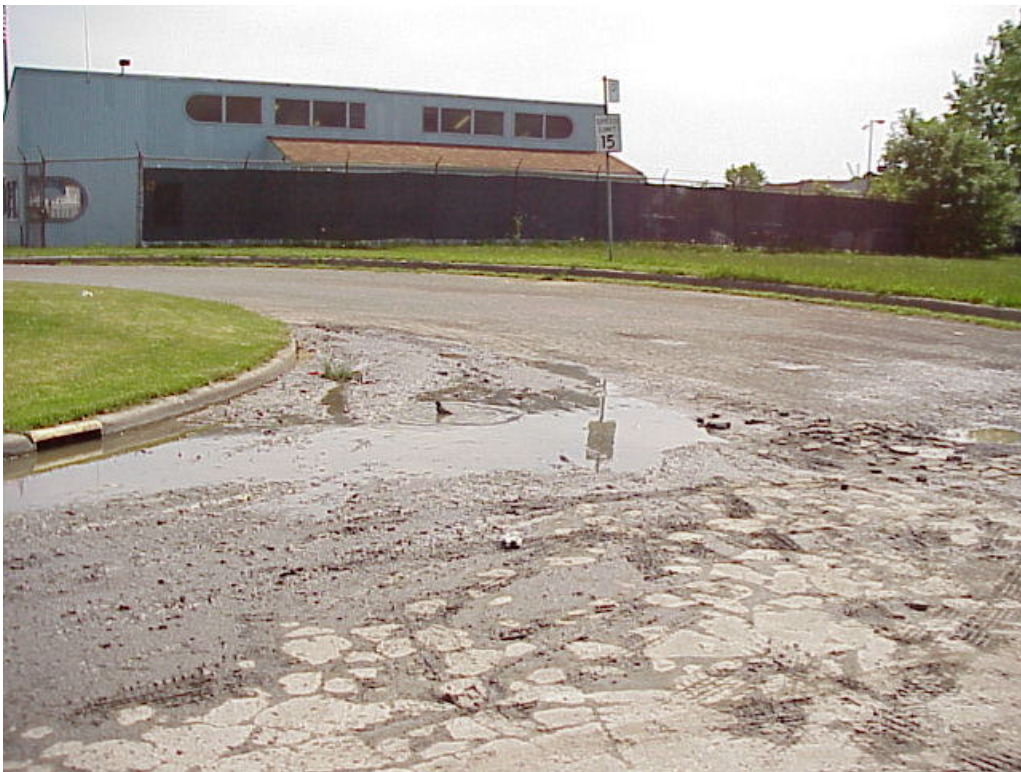
Circle drive to Grayhaven Marina riddled with potholes.
